CONNECTICUT RIVER BASIN
CLAREMONT, NEW HAMPSHIRE

COY DAM

NH 00140

PHASE I INSPECTION REPORT
NATIONAL DAM INSPECTION PROGRAM

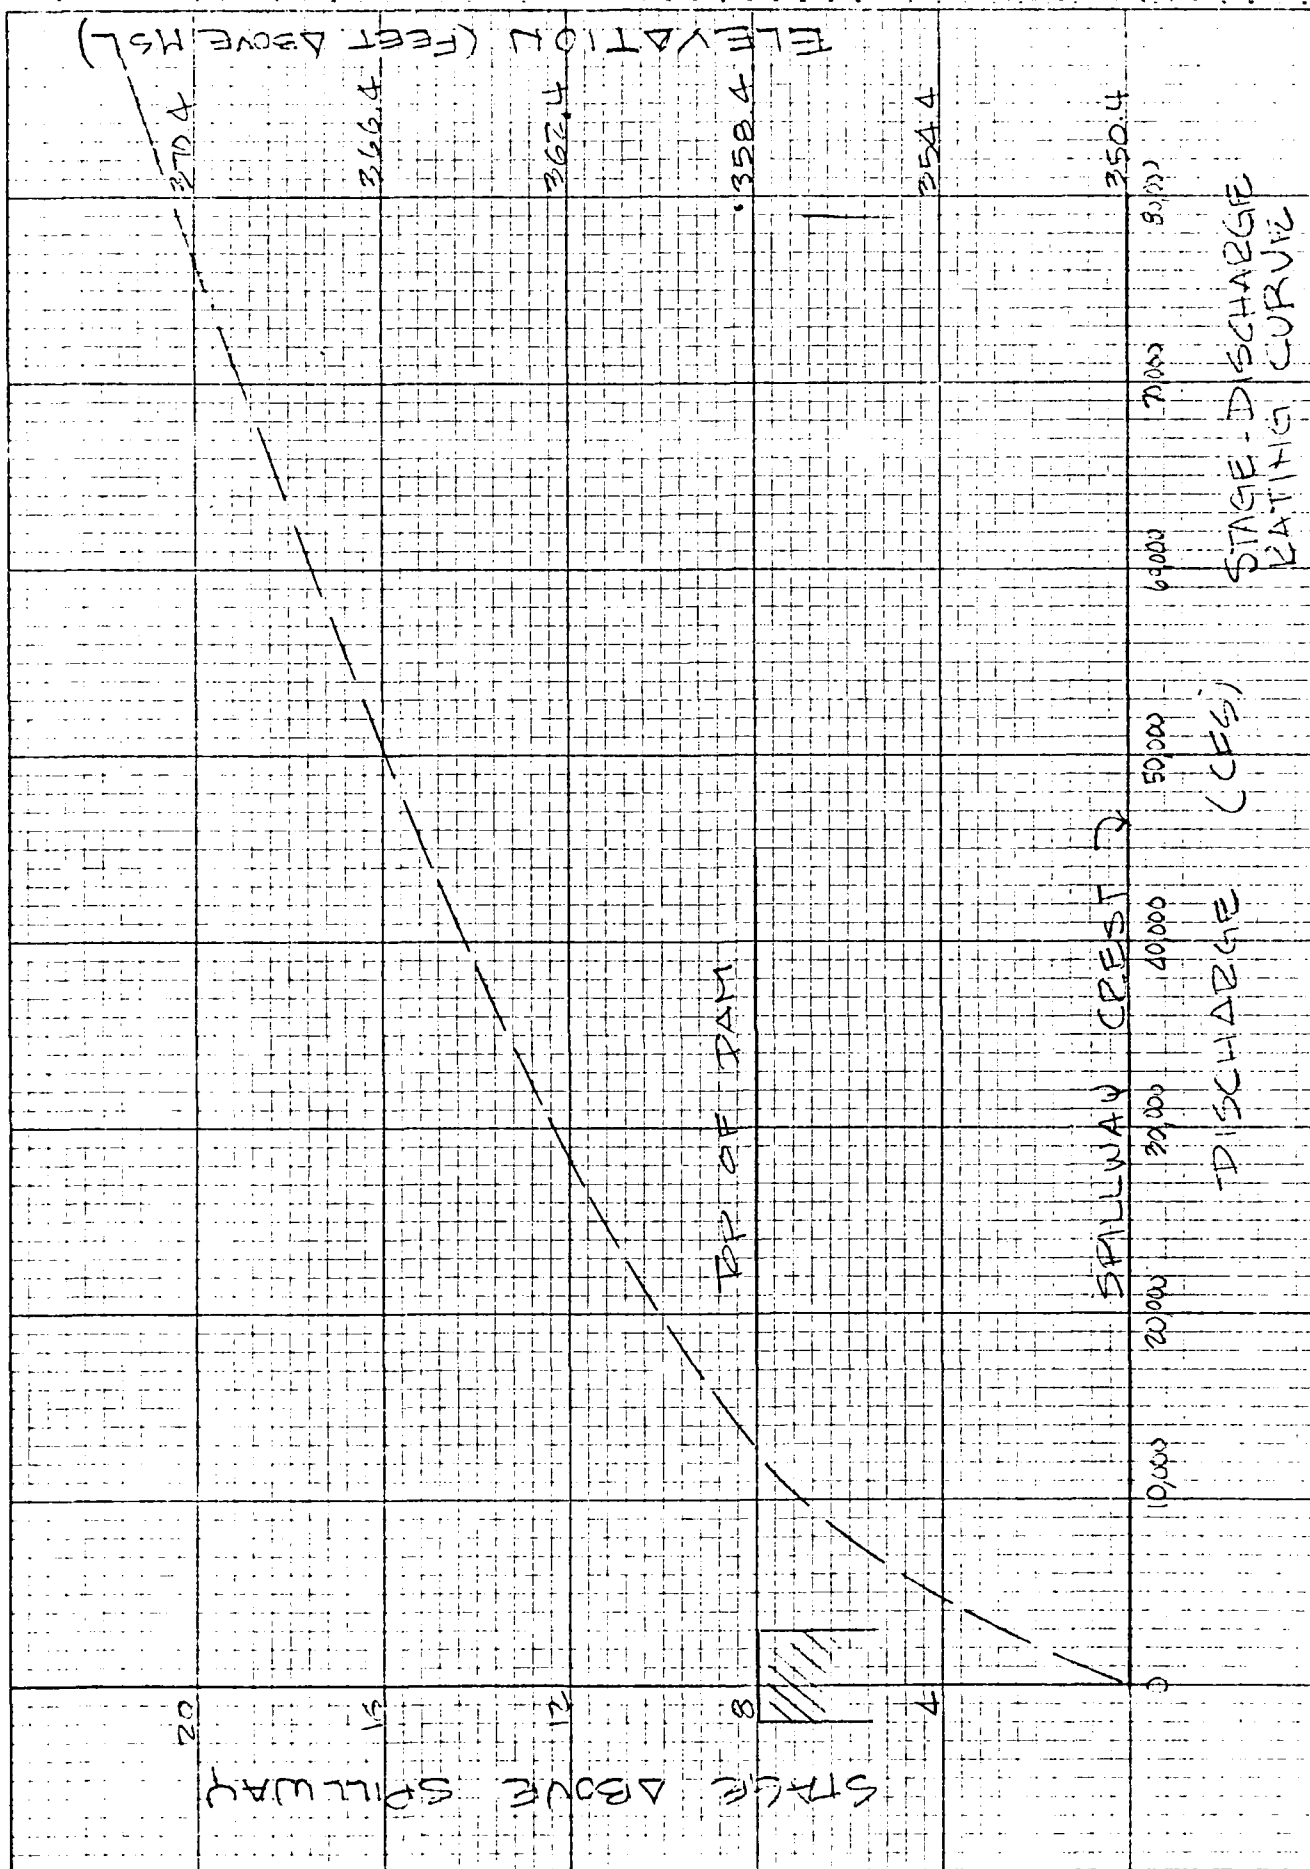
FIG. 1

1. The test Flood discharge will overtop the crest of the dam by approx. 6 Feet.
2. The spillway capacity w/o overtopping is 12,710 CFS which is the 33.8% of the Test Flood discharge. (37,560 CFS)
3. No flashboards are assumed to remain when the test flood passes over the spillway.
4. The available discharge thru the gates is approx 940 CFS. completely opened.
